# Manhole Inspection Summary

Manhole # S4100\_011MH

Insp Date: **2/21/07 9:18 AM**

**Location** Address: **1221 AIKEN ST**

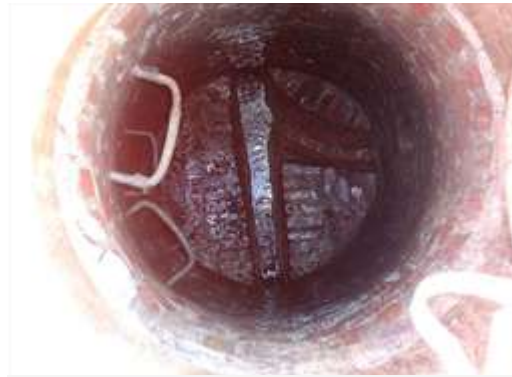
Top View

Corroded steps. Bench debris.

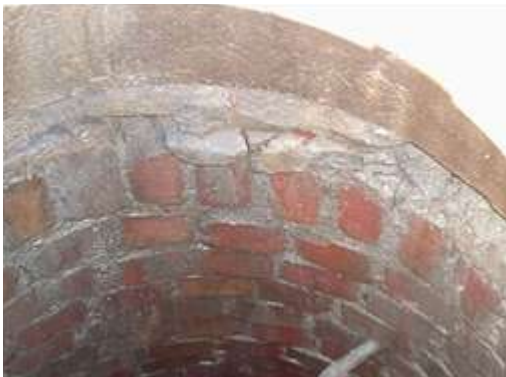
Defect

Frame leaks. Adjustment deterioration and infiltration.

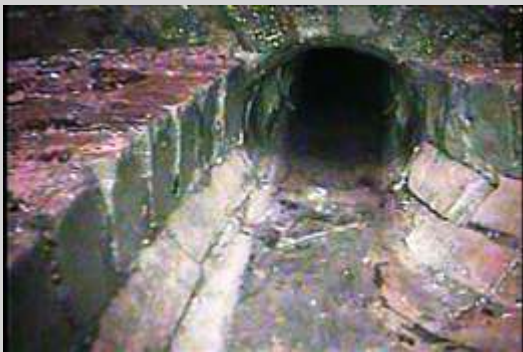
### 8 in. Circular Gravity Sewer Pipe Out @ 12 O'Clock

Channel deterioration.

Infiltration: **Evidence** Pipe Seal Cond: **Unknown**

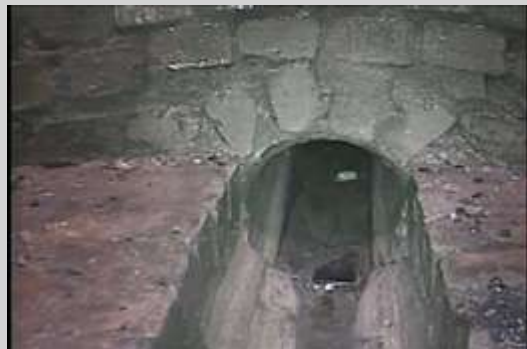
8 in. Circular Gravity Sewer

Deposits: ☐ None ☒ **Mud** ☐ Sludge ☒ **Debris** ☐ Grease

Deposits Extent: **Light**
